Are you sharpening your squeegees?

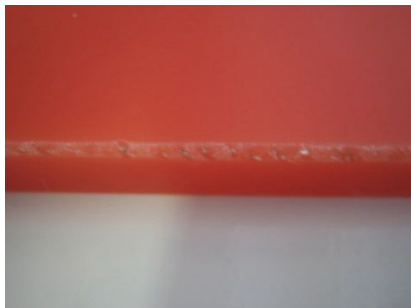
Picture 1 Worn squeegee

After using a squeegee for a long period of time, friction with the screen causes the edge of the squeegee to wear down. Picture 1 shows a worn squeegee. Compared to a squeegee immediately after sharpening as shown in the Picture 2, the edge of the worn squeegee has uneven parts. Pictures 3 and 4 show print results when squeegees of Pictures 1 and 2, respectively, are used. When printed with the worn squeegee, streaks are evident in the print image, compared to that of the sharpened squeegee.

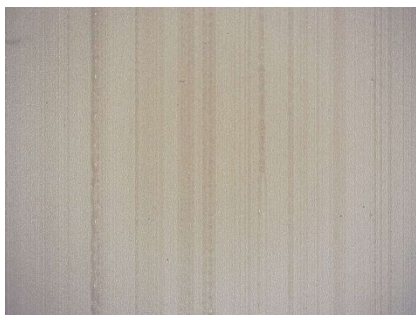
Picture 3 Printed with the worn squeegee

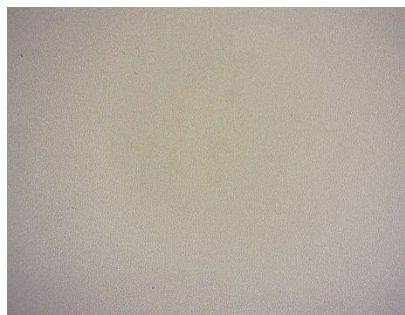
Picture 4 Printed with the squeegee immediately after sharpening

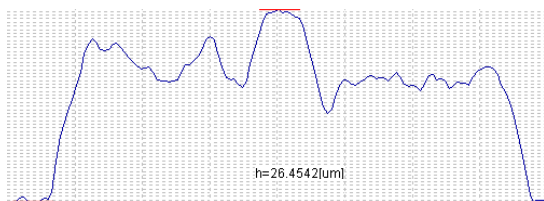
Figure 1 Surface roughness of Picture 3

Print film thickness is measured using a surface roughness gauge and the results are shown in Figures 1 and 2. When the surface of squeegee is uneven, variation in film thickness becomes large.

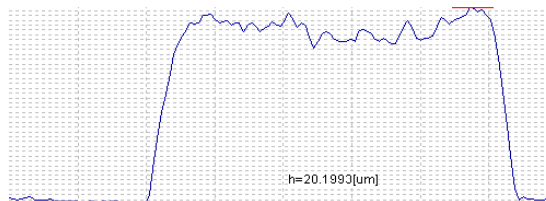
Figure 2 Surface roughness of Picture 4
